## SAE J661 (FEB97) Brake Lining Quality Control Test Procedure

Client	Indubal Camino a Melipilla 10750 Santiago Chile	Work Order No.	122555
Formulation	AF 2080	Test No.	M22-351-22
Sample	A	Date	31 Jul 12
		Technician	F. Thomas
		Prepared By	A. Hinson

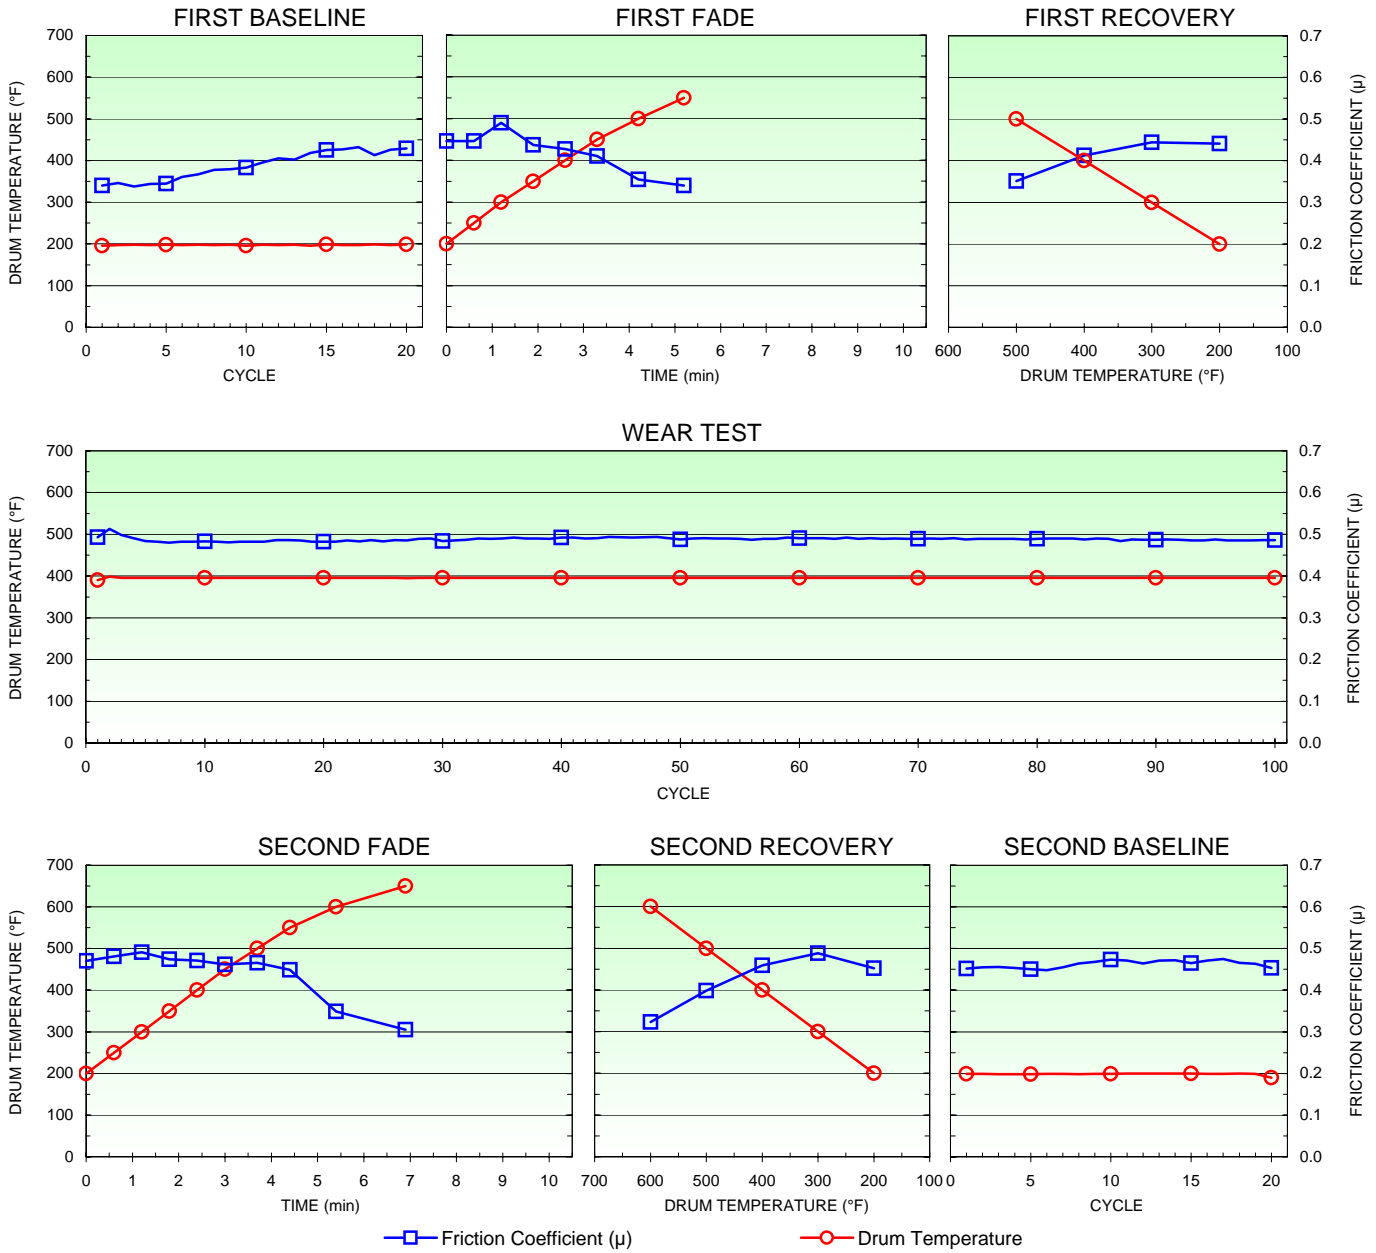
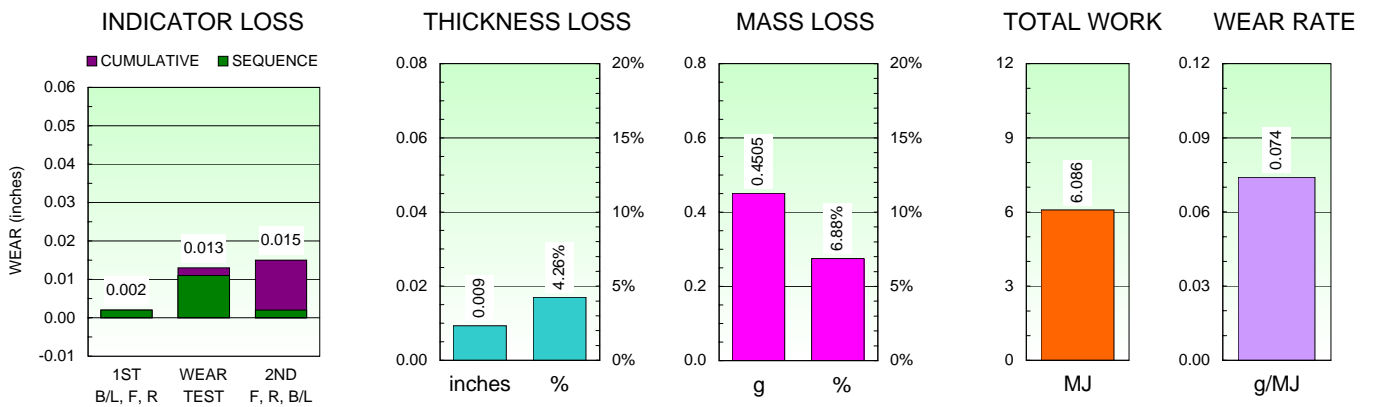
# SAE J661 (FEB97) Brake Lining Quality Control Test Procedure

FIRST BASELINE		
Cycle	Temp °F	μ
1	196	0.34
5	198	0.35
10	196	0.38
15	199	0.43
20	199	0.43

SECOND FADE		
Minutes	Temp °F	μ
0.0	200	0.47 N
0.6	250	0.48 N
1.2	300	0.49 N
1.8	350	0.47
2.4	400	0.47 N
3.0	450	0.46 H
3.7	500	0.47 H
4.4	550	0.45 H
5.4	600	0.35 H
6.9	650	0.31 H

FIRST FADE		
Minutes	Temp °F	μ
0.0	200	0.45
0.6	250	0.45
1.2	300	0.49
1.9	350	0.44
2.6	400	0.43
3.3	450	0.41
4.2	500	0.35
5.2	550	0.34

WEAR TEST		
Cycle	Temp °F	μ
1	390	0.49
10	396	0.48
20	396	0.48
30	396	0.48
40	396	0.49
50	396	0.49
60	396	0.49
70	396	0.49
80	396	0.49
90	396	0.49
100	396	0.49

SECOND RECOVERY		
	Temp °F	μ
	600	0.32
	500	0.40 H
	400	0.46 H
	300	0.49 H
	200	0.45

FIRST RECOVERY		
	Temp °F	μ
	500	0.35
	400	0.41 H
	300	0.44 H
	200	0.44

SECOND BASELINE		
Cycle	Temp °F	μ
1	199	0.45
5	198	0.45
10	199	0.47
15	200	0.47
20	190	0.45

Test Speed = 417 r/min  
 Test Load = 150 lbf  
 μ = Friction Coefficient  
 \* = Temperature not achieved  
 Temperatures reported at onset of application
