## SAE J661 (STABILIZED NOV 2012) Brake Lining Quality Control Test Procedure

Client	Indubal Camino a Melipilla 10750 Santiago Chile	Work Order No.	144485
Formulation	AF2031	Test No.	M22-433-19
Sample	A	Date	12 May 14
		Technician	M. Richey
		Prepared By	A. Vernatter

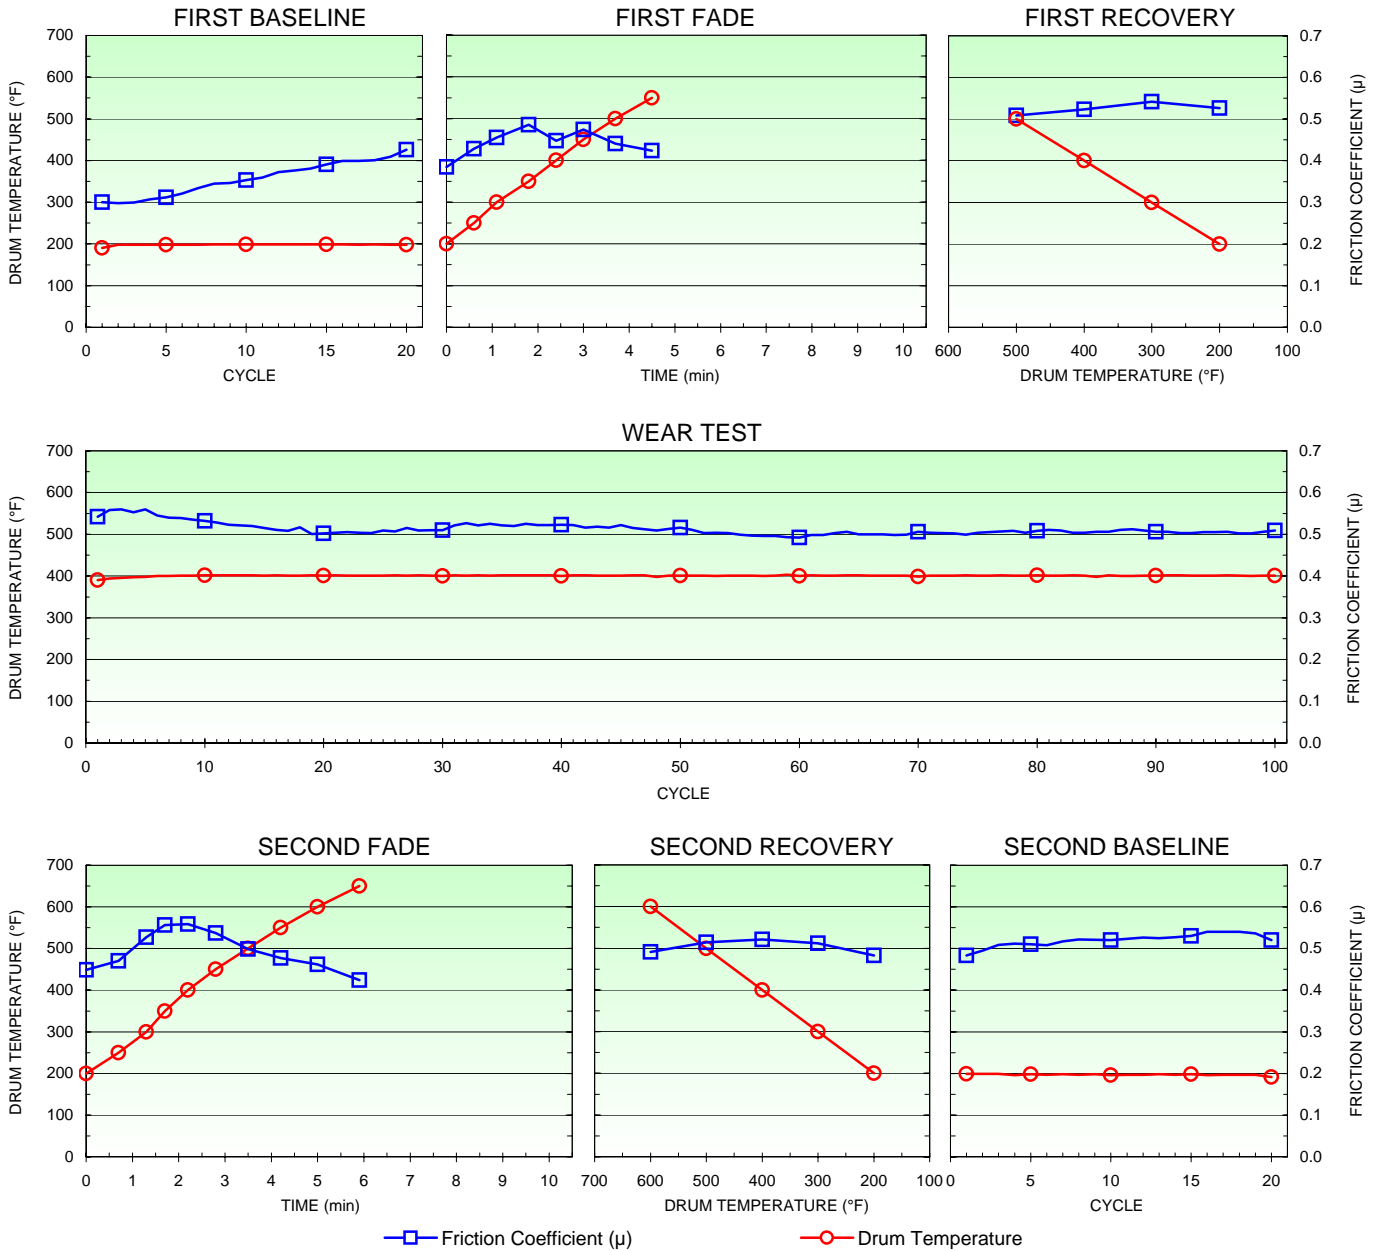
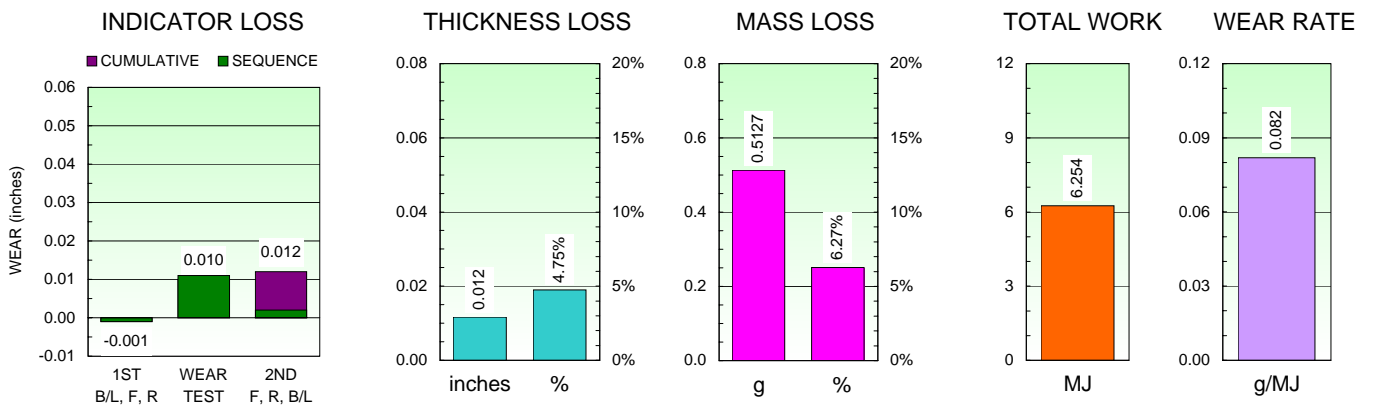
# SAE J661 (STABILIZED NOV 2012) Brake Lining Quality Control Test Procedure

Client Indubal  
Formulation AF2031

Work Order No. 144485  
Test No. M22-433-19

FIRST BASELINE			SAE J866 FRICTION CLASSIFICATION			SECOND FADE				
Cycle	Temp °F	μ	Sum	Mean	Class	Minutes	Temp °F	μ		
1	190	0.30	Normal	2.01	0.501	G	0.0	200	0.45	N
5	198	0.31					0.7	250	0.47	N
10	199	0.35	Hot	5.01	0.501	G	1.3	300	0.53	N
15	199	0.39					1.7	350	0.56	
20	198	0.43	<u>Pre-Wear Indicator (inches)</u>			2.2	400	0.56	N

0.001			2.8	450	0.54	H	
FIRST FADE			WEAR TEST			SECOND RECOVERY				
Minutes	Temp °F	μ	Cycle	Temp °F	μ	<u>Temp °F</u>		<u>μ</u>		
0.0	200	0.38	1	390	0.54	600	0.49

0.6	250	0.43	10	402	0.53	500	0.51	H		
1.1	300	0.46	20	401	0.50	400	0.52	H		
1.8	350	0.49	30	400	0.51	300	0.51	H		
2.4	400	0.45	40	400	0.52	200	0.48			
3.0	450	0.47	50	401	0.52

3.7	500	0.44	60	400	0.49	SECOND BASELINE				
4.5	550	0.42	70	399	0.51	Cycle	Temp °F	μ		
			80	402	0.51	1	199	0.48		
FIRST RECOVERY			90	401	0.51	5	198	0.51		
Temp °F	μ		100	401	0.51	10	196	0.52		
500	0.51		<u>Post-Wear Indicator (inches)</u>			15	198	0.53		
400	0.52	H	-0.010			20	191	0.52		
300	0.54	H	<u>Wear Sequence Loss (inches)</u>							
200	0.53		0.011
