SAE J661 (FEB97) Brake Lining Quality Control Test Procedure

Client	Indubal Camino a Melipilla 10750 Santiago Chile	Work Order No.	111689
		Test No.	M22-325-13
		Date	26 Aug 11
Formulation	BIN	Technician	T. Stefanski
Sample	A	Prepared By	A. Vernatter

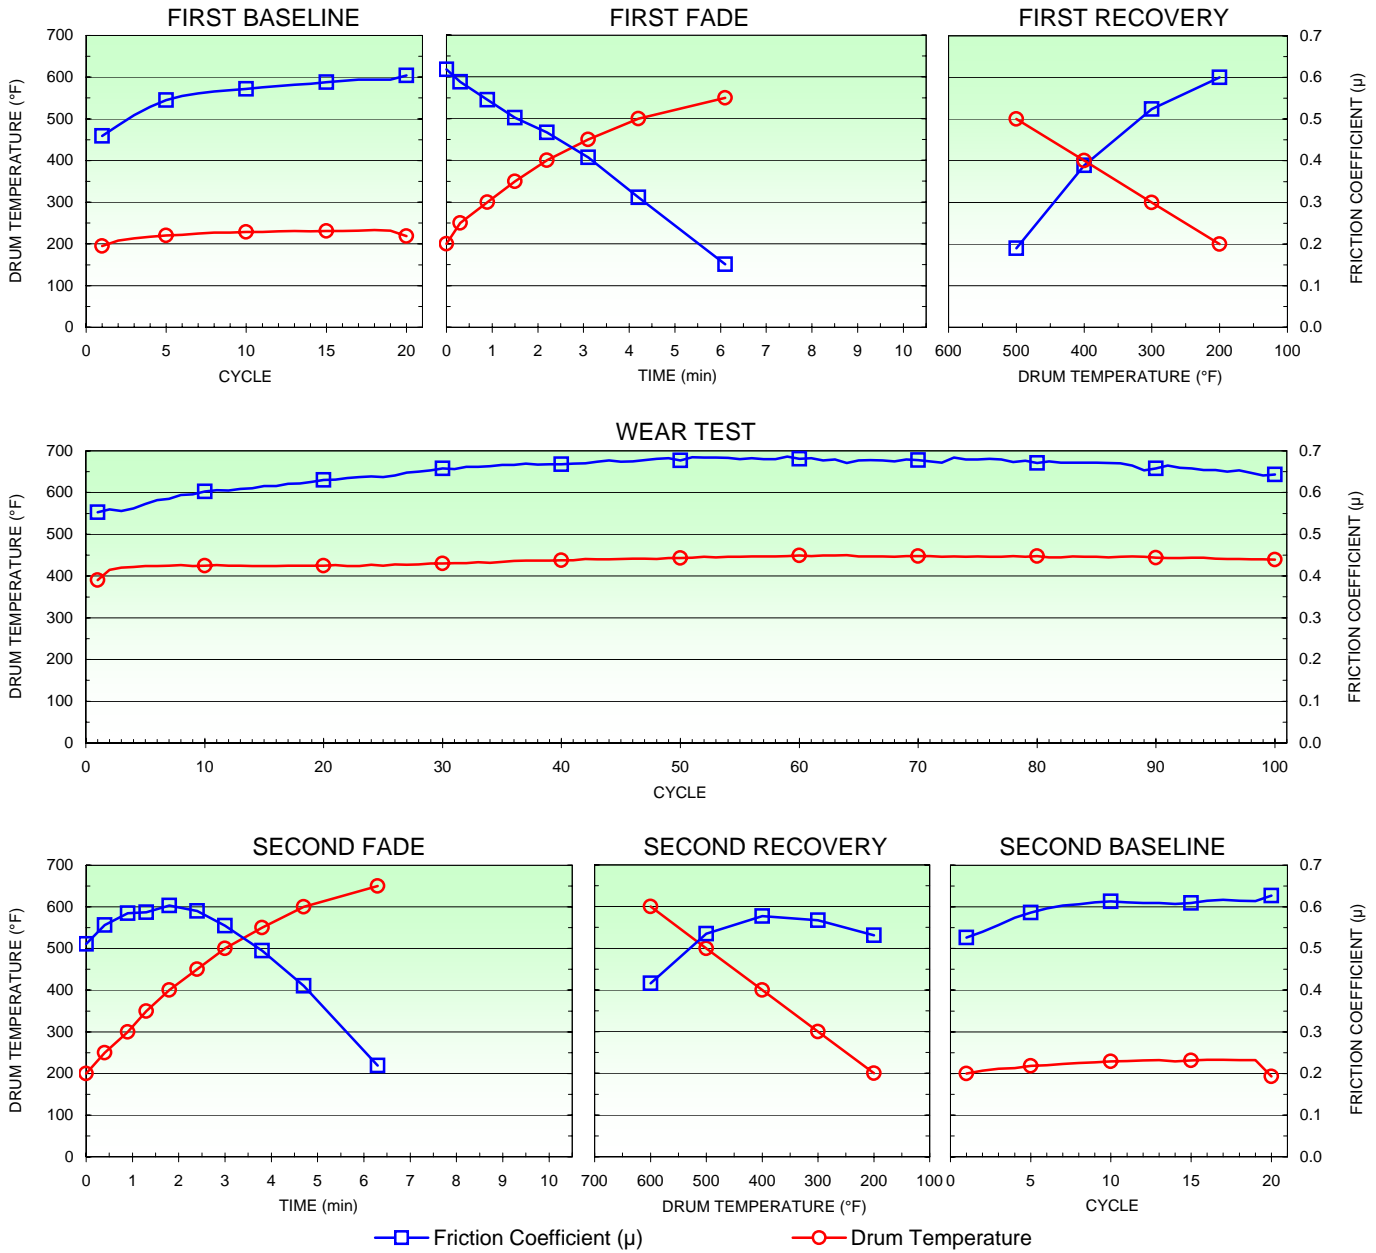
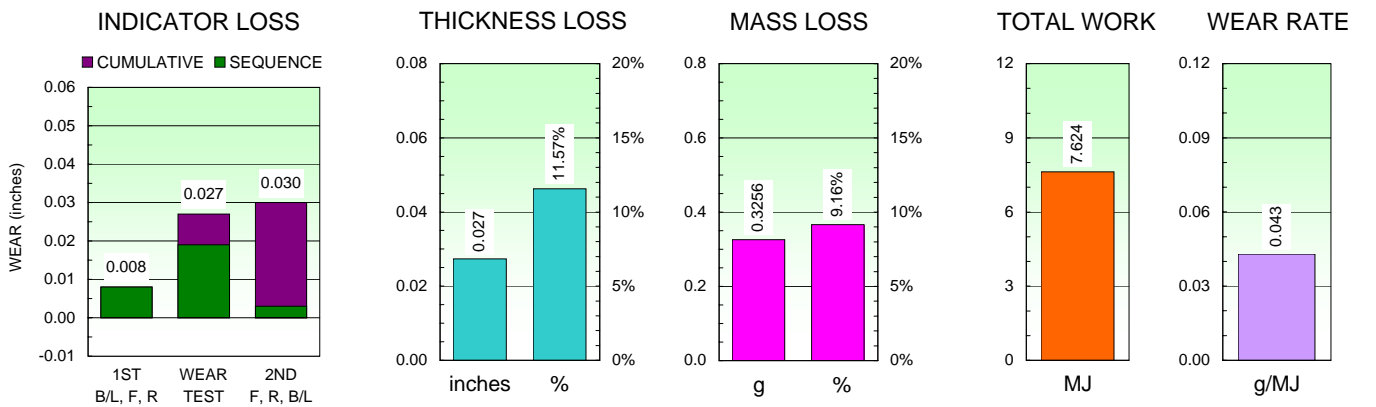
SAE J661 (FEB97) Brake Lining Quality Control Test Procedure
